Knights of Pythias Greenwood Cemetery

Cemetery Head House
Assessment of Period of Significance
Adams Street | Philadelphia | Pennsylvania

EWINGCOLE PROJECT NUMBER: 200900569

November 6, 2009

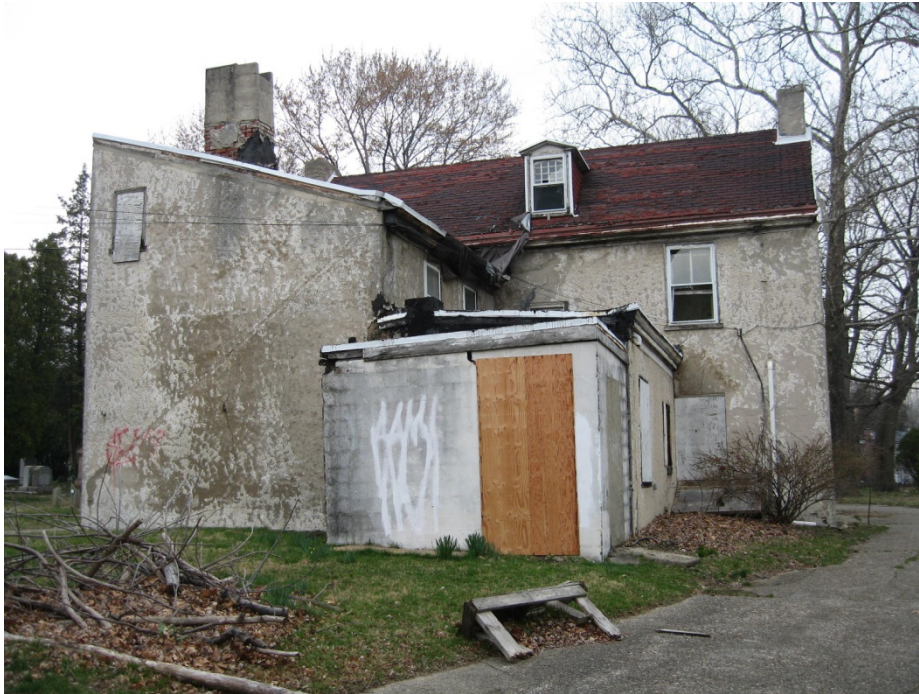
Rear View from March 2008

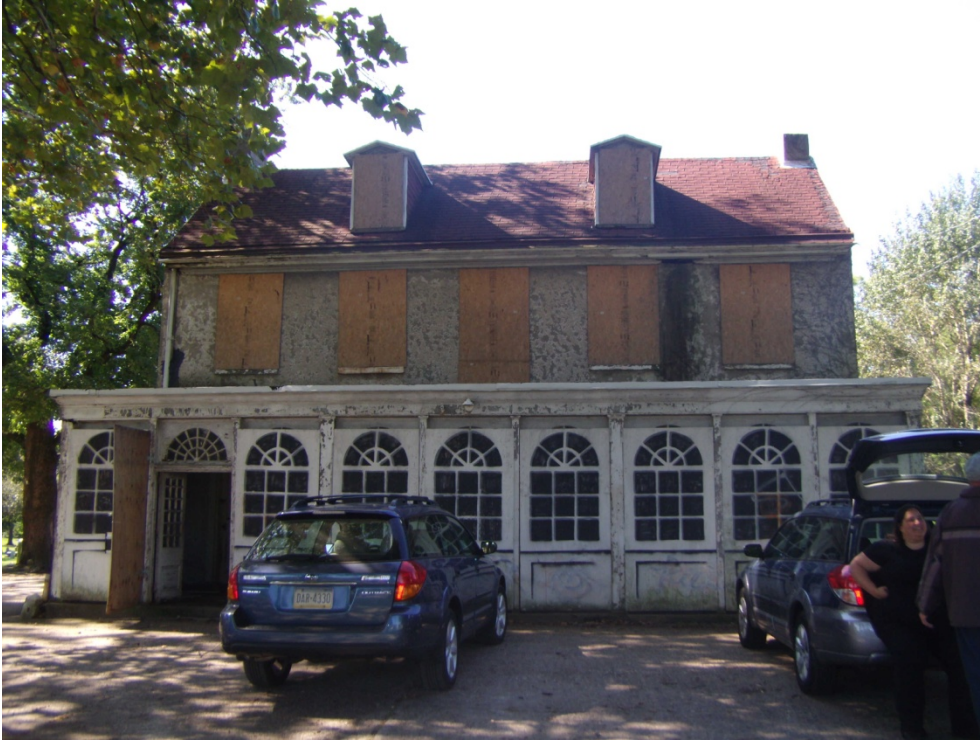
Front Elevation from October 2009

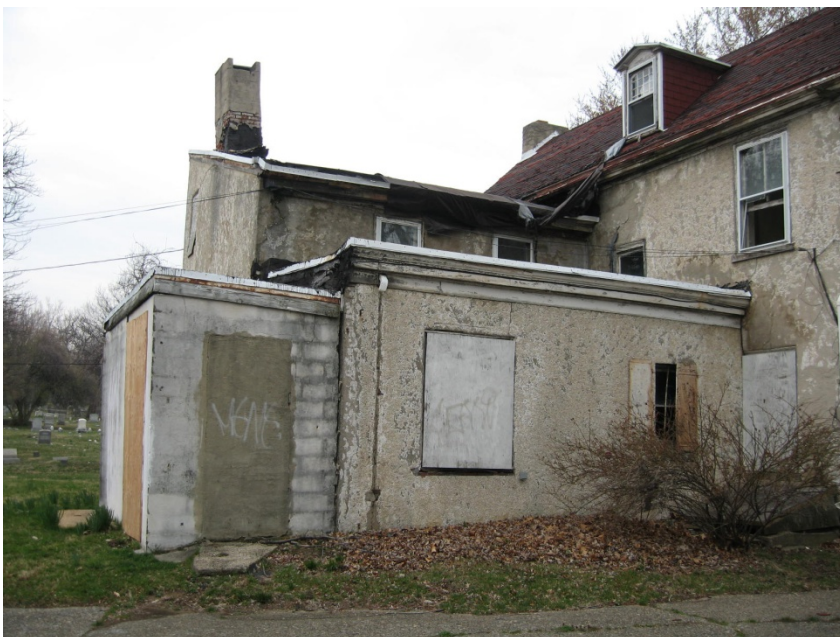
Rear View from March 2008

The concrete block addition will be removed and the single story addition at the rear of the building will be removed and the single story addition will be clad in stucco with single lite double hung windows and a metal roof. The metal was selected as the low slope and relationship to the existing window openings on the main house and two story addition indicate that the slope was likely always as it is seen today. The single lite windows were selected as the windows that exist there today are not likely the original location as some variations were noted in the image of the renovated home from sometime around 1914.

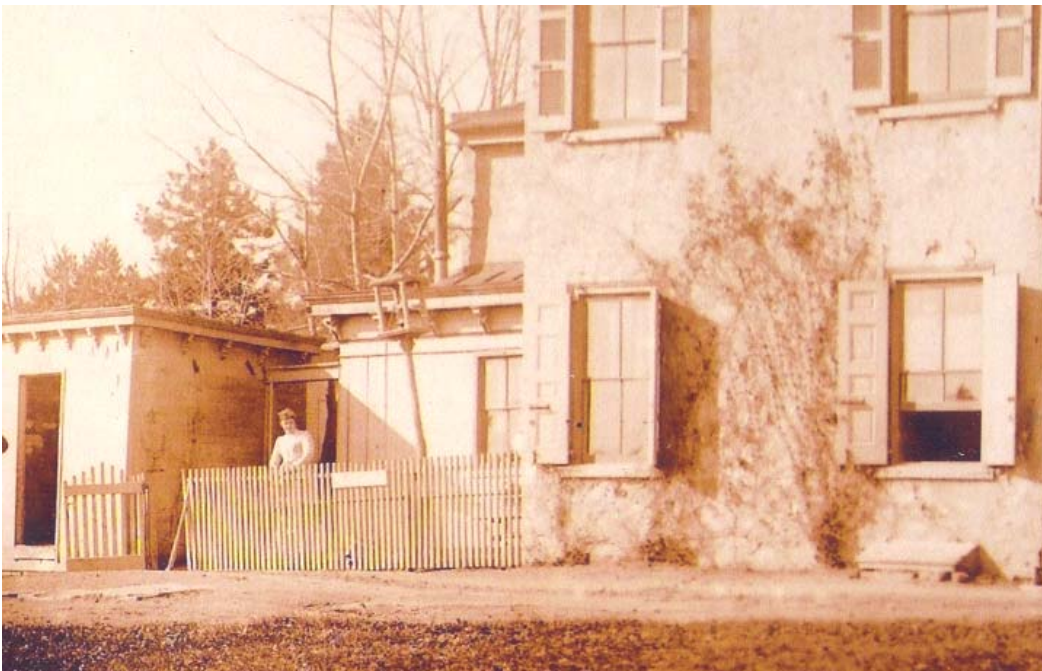
View of the additions on the house in the early 1900's: note the metal roof and window locations on the single story addition.

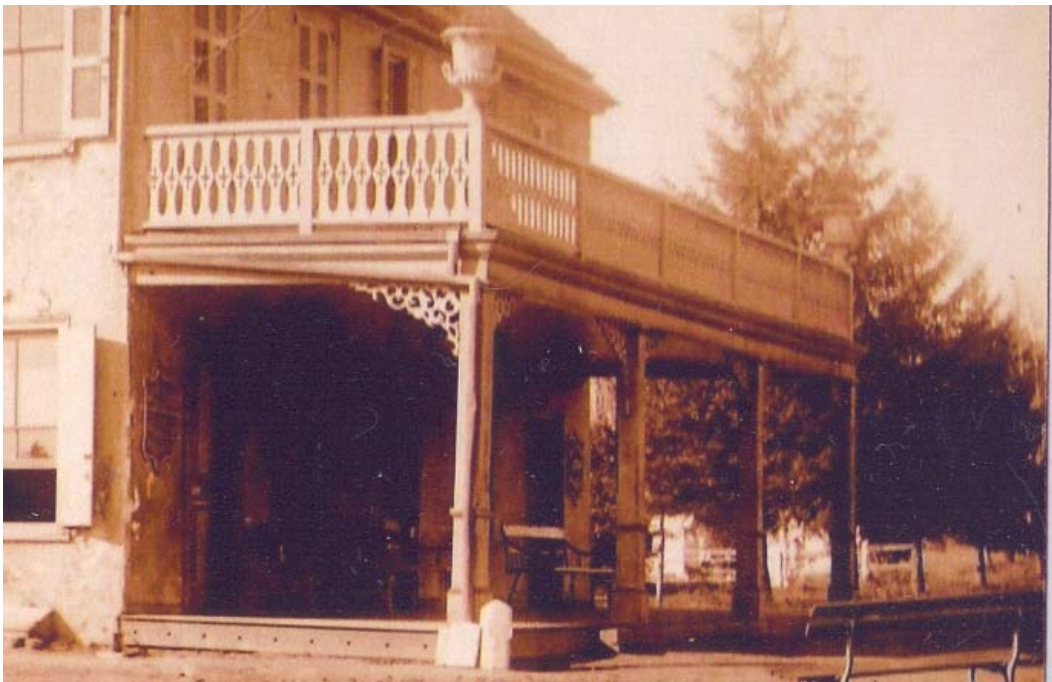
View of the porch on the house in the early 1900's: note interior ceiling height of porch

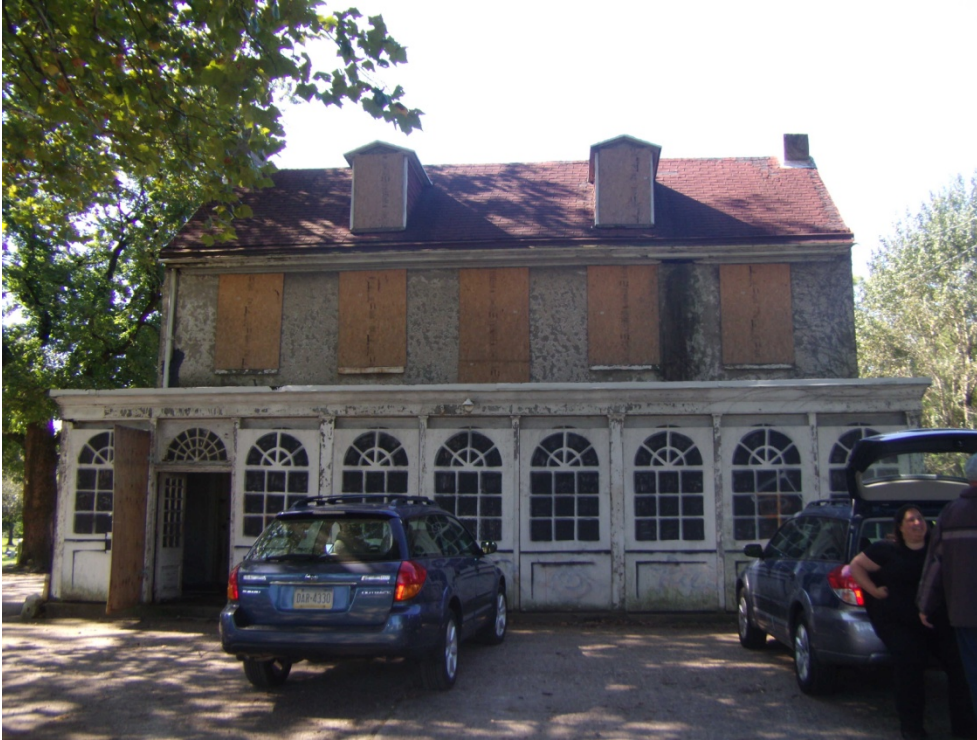
It is likely that the porch was an open roof structure during the period of significance and will be restored to this configuration during the exterior restoration. The photograph from around the period of significance seems to present a shadow that appears to contain an open roof and in addition to being a common detail for this period of construction the fan lite over the door has been truncated by the enclosed ceiling as seen in the images below. This is not likely a desired or original detail.

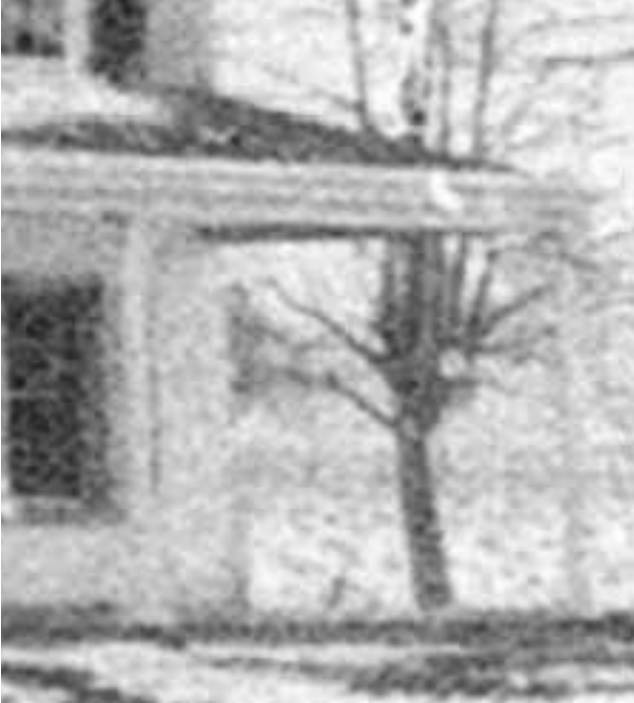
Image of edge of porch showing shadow at roof from near the Period of Significance (1830 - 1850)

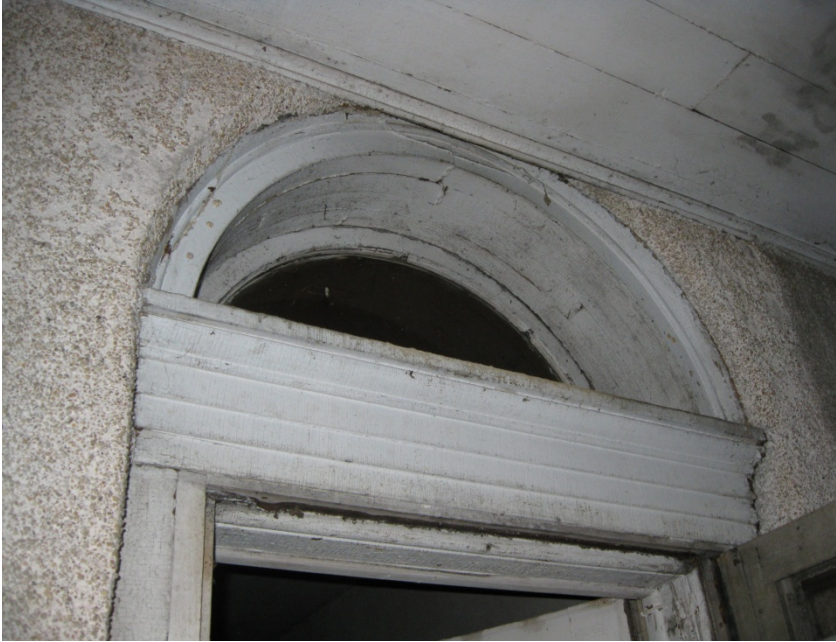
Image of front door exterior with fan light from October 2009: note truncated trim at top of window

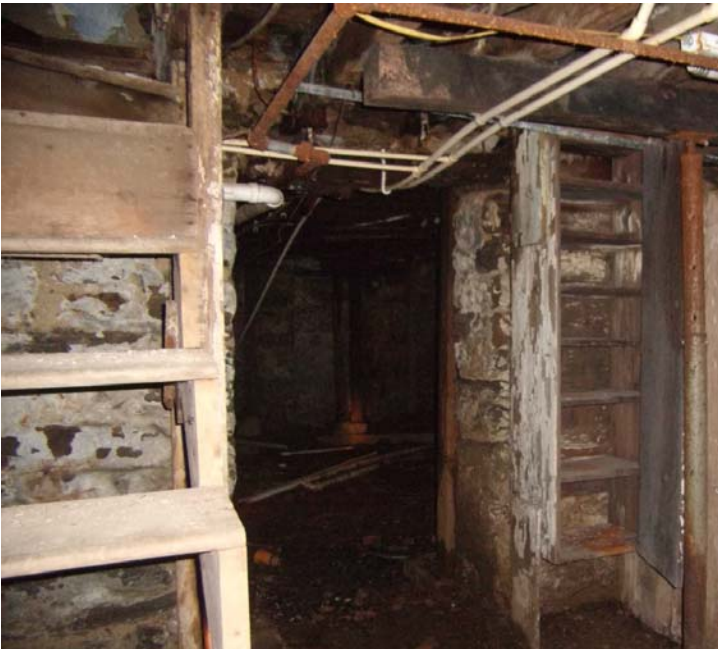
The basement foundation exists under the main house and two story addition. The single story addition has a crawl space that is connected by smaller openings from the two story addition basement space. The connection between the main house basement and the two story addition basement spaces appears to be part of the original construction and not a later modification that lends to the conclusion that the addition and house were built at the same time.

Image of opening between from the main house basement into the addition basement from October 2009

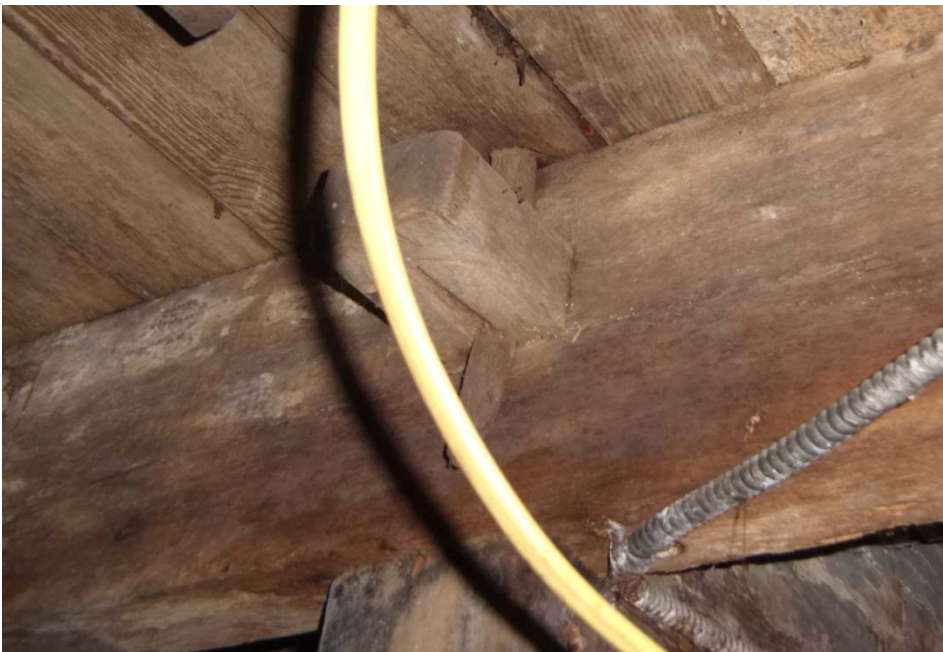
The framing and structure in the basement has been altered as the house was modified. The original framing appears to be a tight mortise and tenon connection between members that was found during the period of significance. Looser mortise and tenon connections would have been common in 18th century construction. With the use of more precise machinery, this connection was made tighter and stronger in the early 19th century.

Image of tight mortise and tenon from the main house basement from July 2009

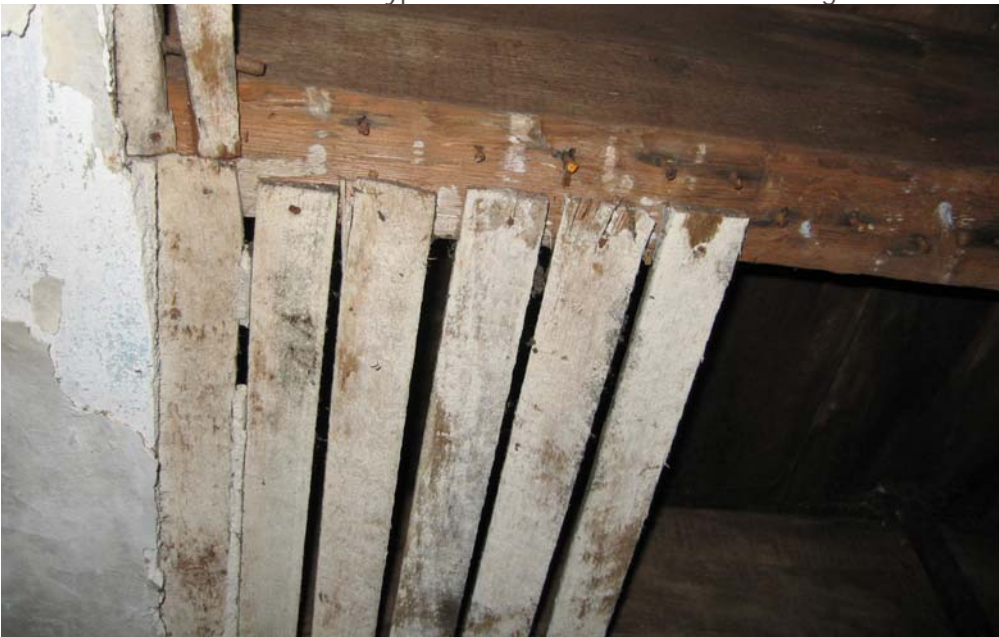
The interior lath and structure only indicate one generation of nails. The lath is not a hand hewn but a circular sawn lath. This type of saw was not used in this region until the early 1800's.

Image of circular sawn lath and nailing used in this area in the early 19th century

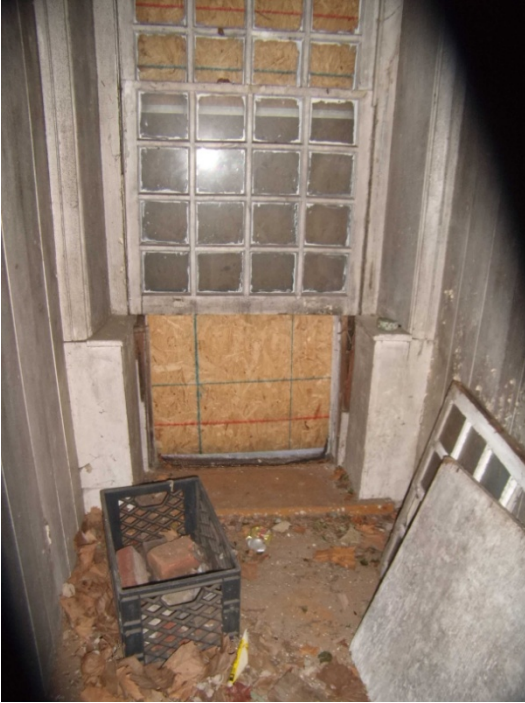
The interior of the center window on the second floor reflects the renovation in the mid 1900's when the window was converted into a door to access the top of the porch roof.

Image of the interior of the center window on the second floor from October 2009

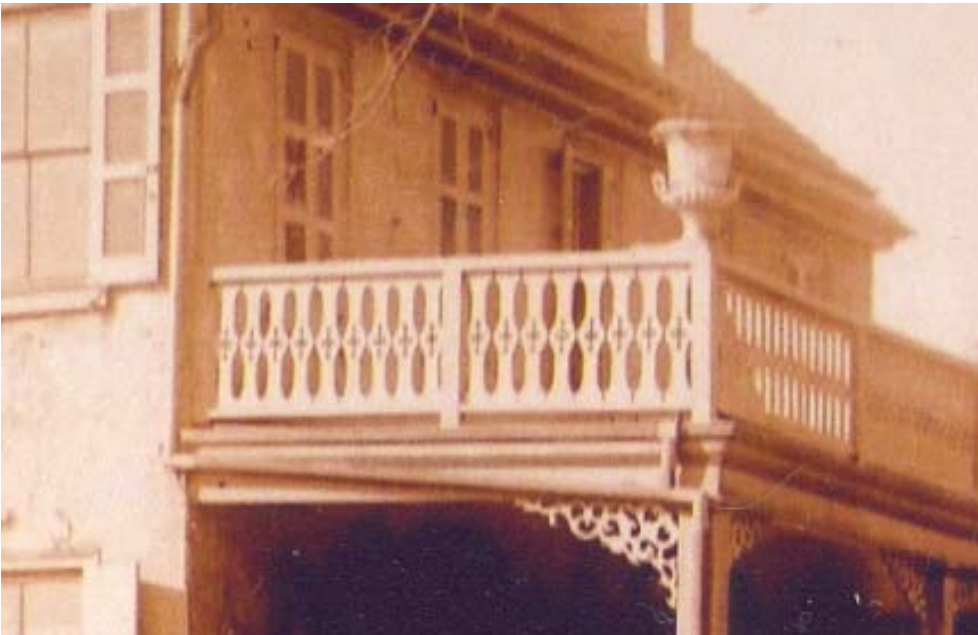
Image of the porch from the mid 1900's showing a door at the center window location.

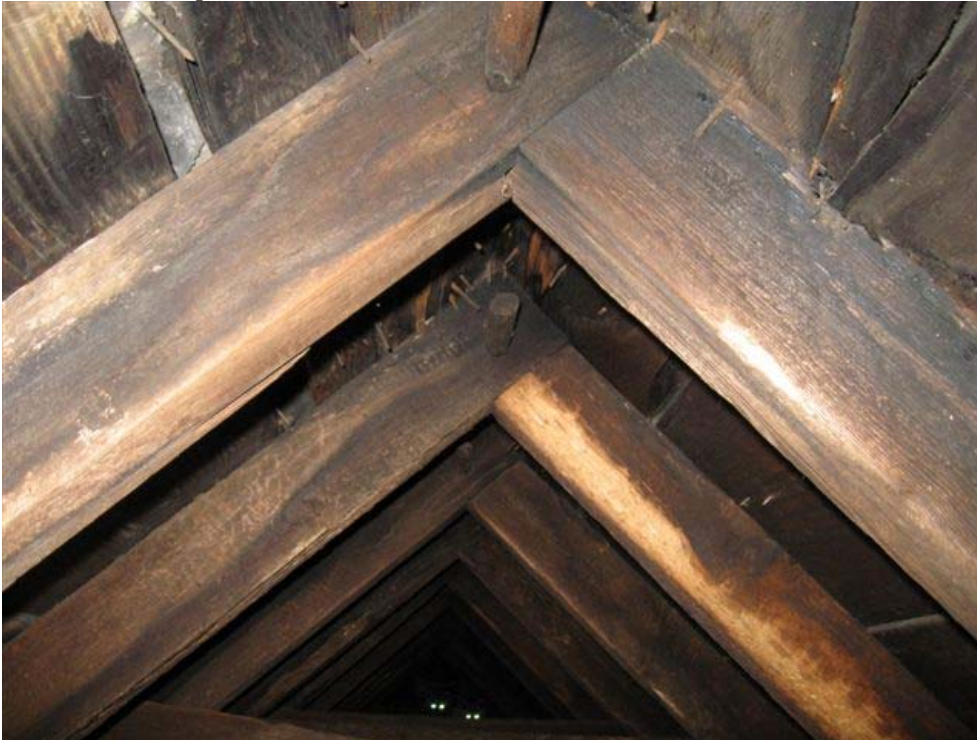
The roof rafters are half-lapped with wood peg pins at the ridge; plus the "sill" plate has that half-lap detail, again with a wood peg. This could have been inductive of an 18th century solution however the collar ties just below the ridge are not pegged nor let into the rafters, and the sizes and cuts of the joists are not from the 1700s.

Image of the roof rafter framing from October 2009

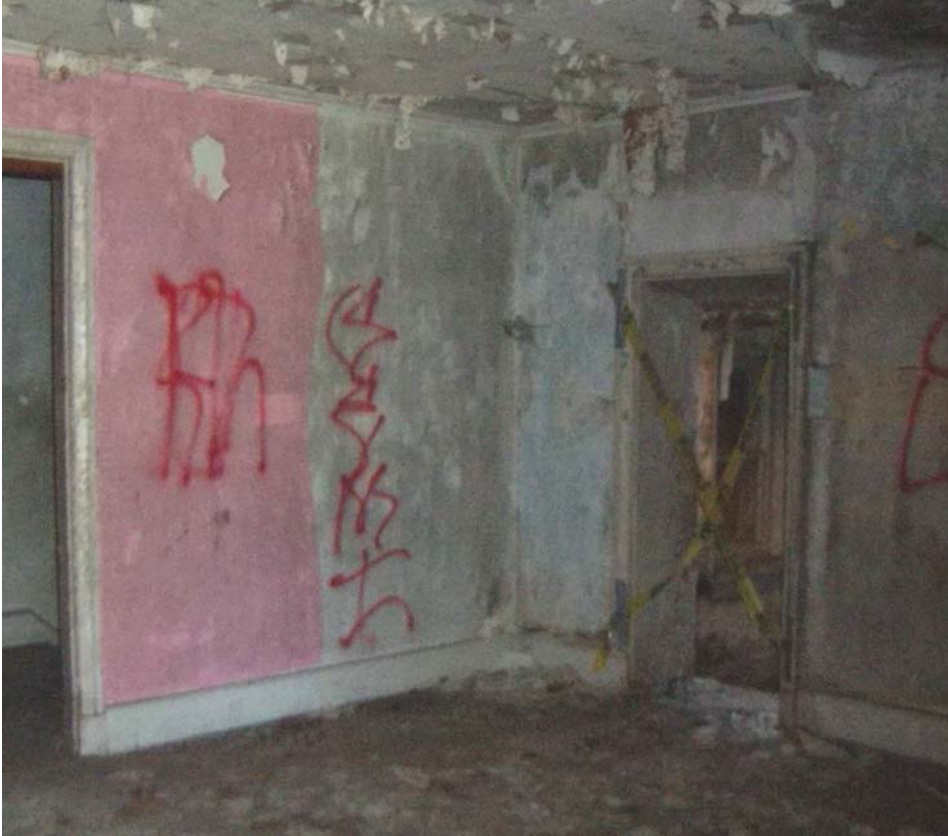
The doorway between the 2nd floor front and 2nd floor rear two story addition was originally a window. The original wood lintel is still intact about two feet above the door head and the gap is simply plastered - no masonry fill. It is not clear why this would have been a window if the two story addition had always been two stories. It appears that the two story addition was a two stories during the period of significance of the home as the framing detailing is similar to the framing in the remainder of the house. Further investigation on the interior is recommended with the interior restoration project.

Image of the connecting door that was a window on the second floor of the house from the main house looking into the two story addition from October 2009

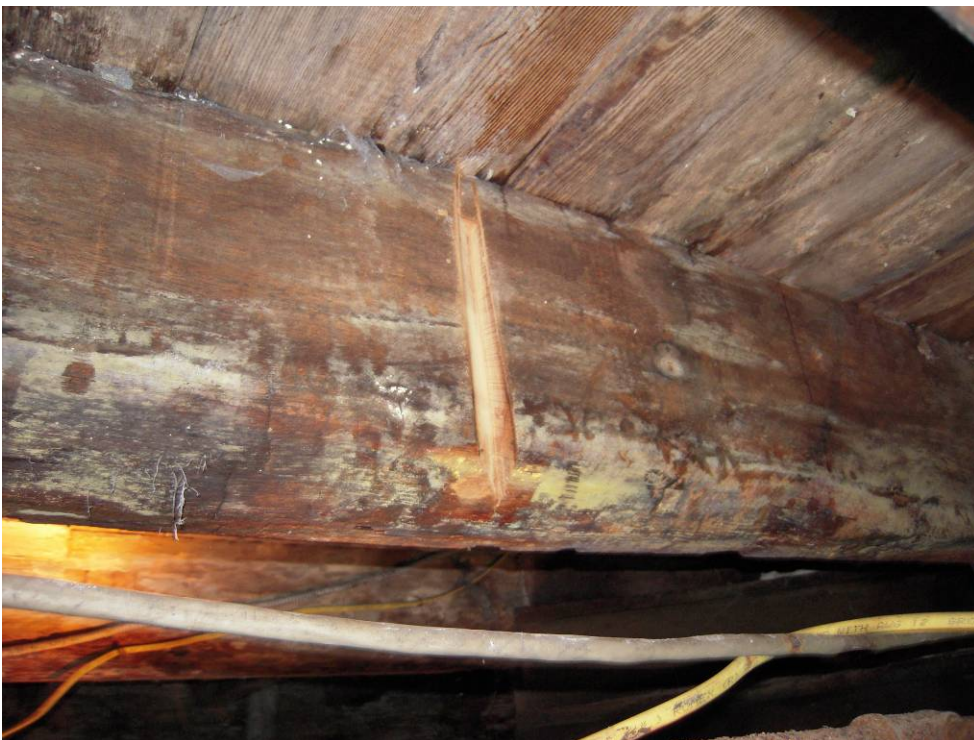
Area of sample GWCH01, ground level joist – near stairs.

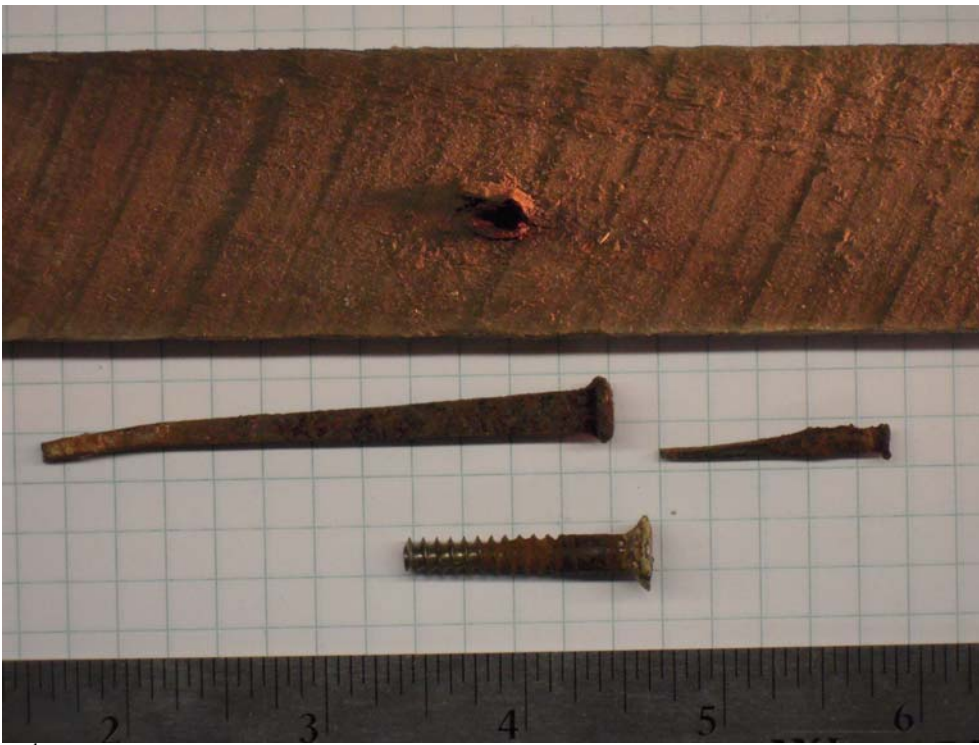
19th century technology found within interior (lath, nails and screw)

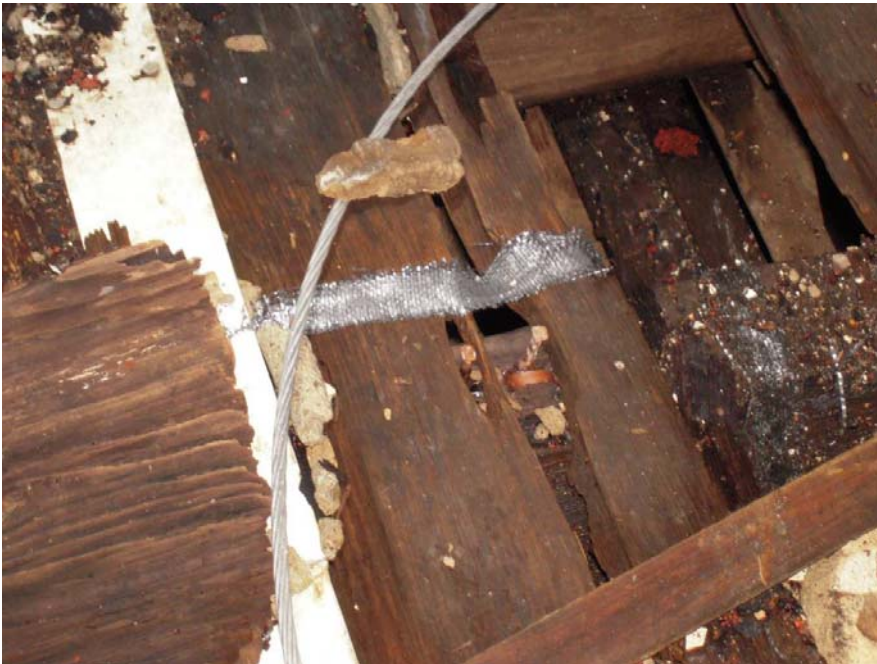
Area of wood flooring, 2nd Floor, with 19th century evidence
